10 problems with the PlayPump

7.4 Ten faults identified in the *PlayPump* system

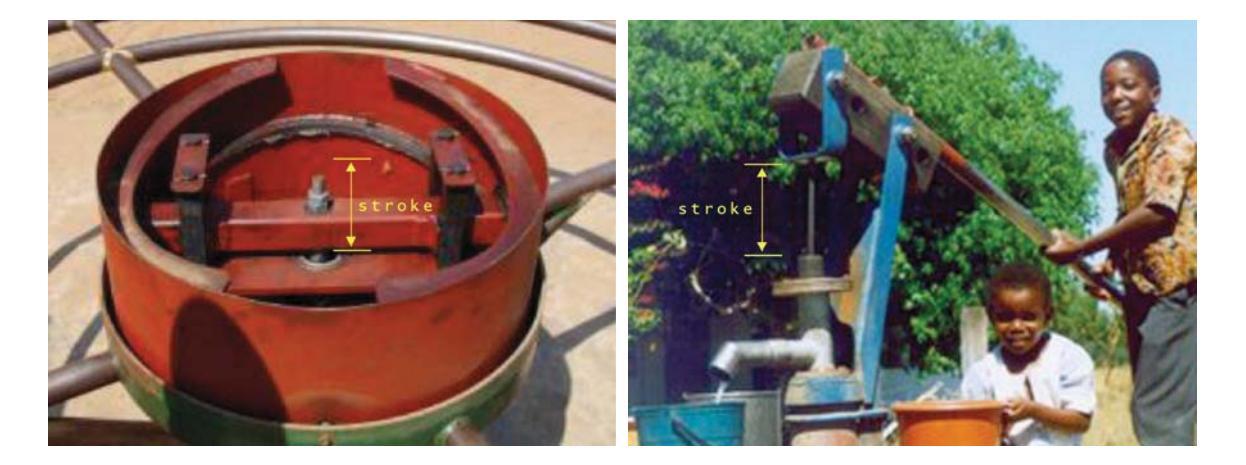
But both UNICEF's and SKAT's reports draw attention to a mechanical limit which restricts its performance of any *PlayPump*. Because of the configuration of the pump head, restricted by its containment within the roundabout, the *PlayPump* has a very short pumping stroke (the up and down travel of the mechanism that lift water up the borehole). The roundabout uses an unusual interior mechanism to drive the pump (see fig 7.3 below), whereby the circular movement of the roundabout raises and drops the pump valve twice on every rotation, pushing it along two curved tracks within the roundabout, rather than using the lever action of a conventional handpump. As a result, the pump stroke for the *PlayPump* is on average about 6.5 cm, compared to 22cm on the AfriDev, for example, Mozambique's national standard handpump (Obiols & Erpf 2008). As the *PlayPump* operates on the same boreholes as handpumps, using a similar range of cylinder sizes, this means it must pump less water per stroke than a conventional handpump.

Fig 7.3: The interior of the *PlayPump's* headgear, left (Obiols & Erpf 2008, p.21); and the Zimbabwe Bush Pump's headgear, showing the much longer travel of the pump mechanism, right (arrows and text added).

Erpf calculates in his report the maximum theoretical pumping rate of a *PlayPump*, using a simple formula: he calculated the amount of water pumped on each stroke according to the cylindrical volume of water displaced, multiplied by the number of rotations per minute, multiplied by 2 as there are two pump strokes per rotation of the roundabout. For a *PlayPump*

using a 50mm diameter cylinder, the same size as the smallest diameter Zimbabwe Bush Pump and AfriDev handpump – more about the range of diameters of *PlayPumps* follows – this is calculated below. Erpf used 20 rotations of the roundabout per minute as his measure, rather than the 16 on which Roundabout Outdoor's claim is based; this will be corrected for shortly:

Calculation of projected cylinder area: $d2 \ge \pi/4$ or $52 \ge 3.1416/4 = 19.63$ cm2

Calculation of discharge/stroke: 19.63 cm2 x 6.5 cm = 127.59 cm3 = 0.128 litres

Discharge per minute (20 RPM) 2 x 20 strokes x 0.128 litres = 5.12 litres

Discharge per hour 60 x 5.12 litres = 307.2 litres

So at 20 rotations per minute, a *PlayPump* with a 50mm diameter cylinder pumps a maximum of 307.2 litres per hour, in ideal conditions. The manufacturer's claim is based on 16 rotations per minute; if we use Erpf's formula, but for 16 rotations per minute instead of 20, we arrive at only 245.8 litres per hour. This is for the smallest cylinder; there are two larger sizes of cylinder used by *PlayPumps* (the size of cylinder varies according to the size of the borehole the pump is installed on): using Erpf's formula, the 80mm diameter, which is the largest size cylinder used in Mozambique (Obiols & Erpf 2008, p.25) could pump a maximum of 627.8 litres per hour at 16 rotations per minute, and the 100mm diameter cylinder, used only on shallow wells in South Africa (ibid), 979.2 litres per hour at 16 rotations per minute. Rather than 1,400 litres per hour, we have a range from roughly 250 litres per hour to 980 litres per hour, as absolute maximum, ideal values; and in Mozambique, no more than 630 litres per hour, as the largest cylinder used in that country is 80mm.

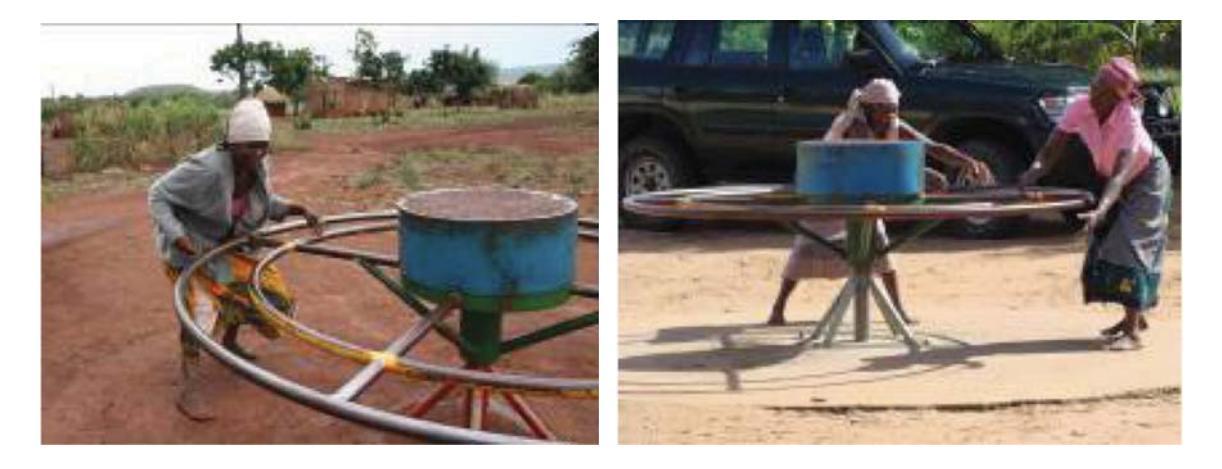
Both UNICEF's and SKAT's reports observe that adults are frequent users of the *PlayPump*. Because both the pumping rate of the system and the number of people it can supply are exaggerated several-fold, children's play cannot produce enough water to meet the needs of the community, and so adults – uniformly women – must operate the *PlayPump's* roundabout. They do this by standing next to the roundabout and turning it by hand (Obiols & Erpf 2008).

Fig 7.5: Women turning the PlayPump's roundabout by hand, from SKAT's report in Mozambique (2008)

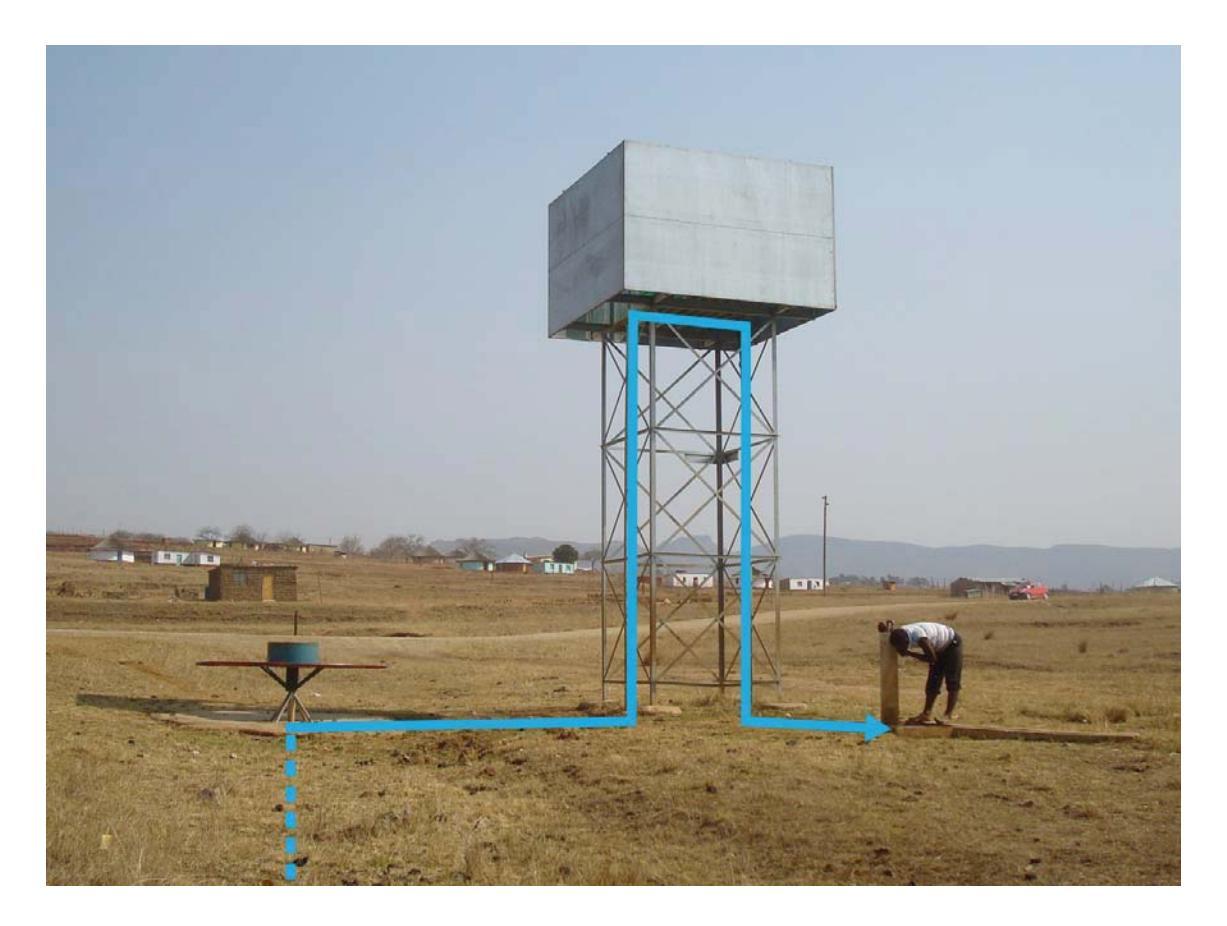
UNICEF's study states the problem that resulted: "This means excessive work is needed to raise the water to the elevated tank with no additional benefit accrued" (UNICEF 2007, p. 9). Looking at the diagram of the *PlayPump* system in Fig 7.6, overleaf, the problem can be observed: where a conventional hand-pump supplies water directly from the top of the borehole, the *PlayPump* pumps it first a distance of several metres horizontally from the roundabout-pump to the base of the elevated water tank, then up 7 metres to the tank – this vertical upwards distance is the most significant, working against gravity – down again, and

then several more metres across the ground to the faucet from where water can be drawn. When the tank is empty, the water has to be pumped across this whole distance every time.

Fig 7.6: The distance water has to travel from the borehole to the standpipe. Photograph by the author.

With every rotation I could hear a small splash of water in the tank (about 20ft above), followed by a splash of water into the lady's bucket on the ground beside us. Because the tank wasn't full (which I figure they almost never are), the lady was essentially having to exert herself to move the water 20ft upwards, just to have it come back down again. I don't know what you think, but to me it seemed like a bit of unnecessary extra effort to fill a bucket (ibid).

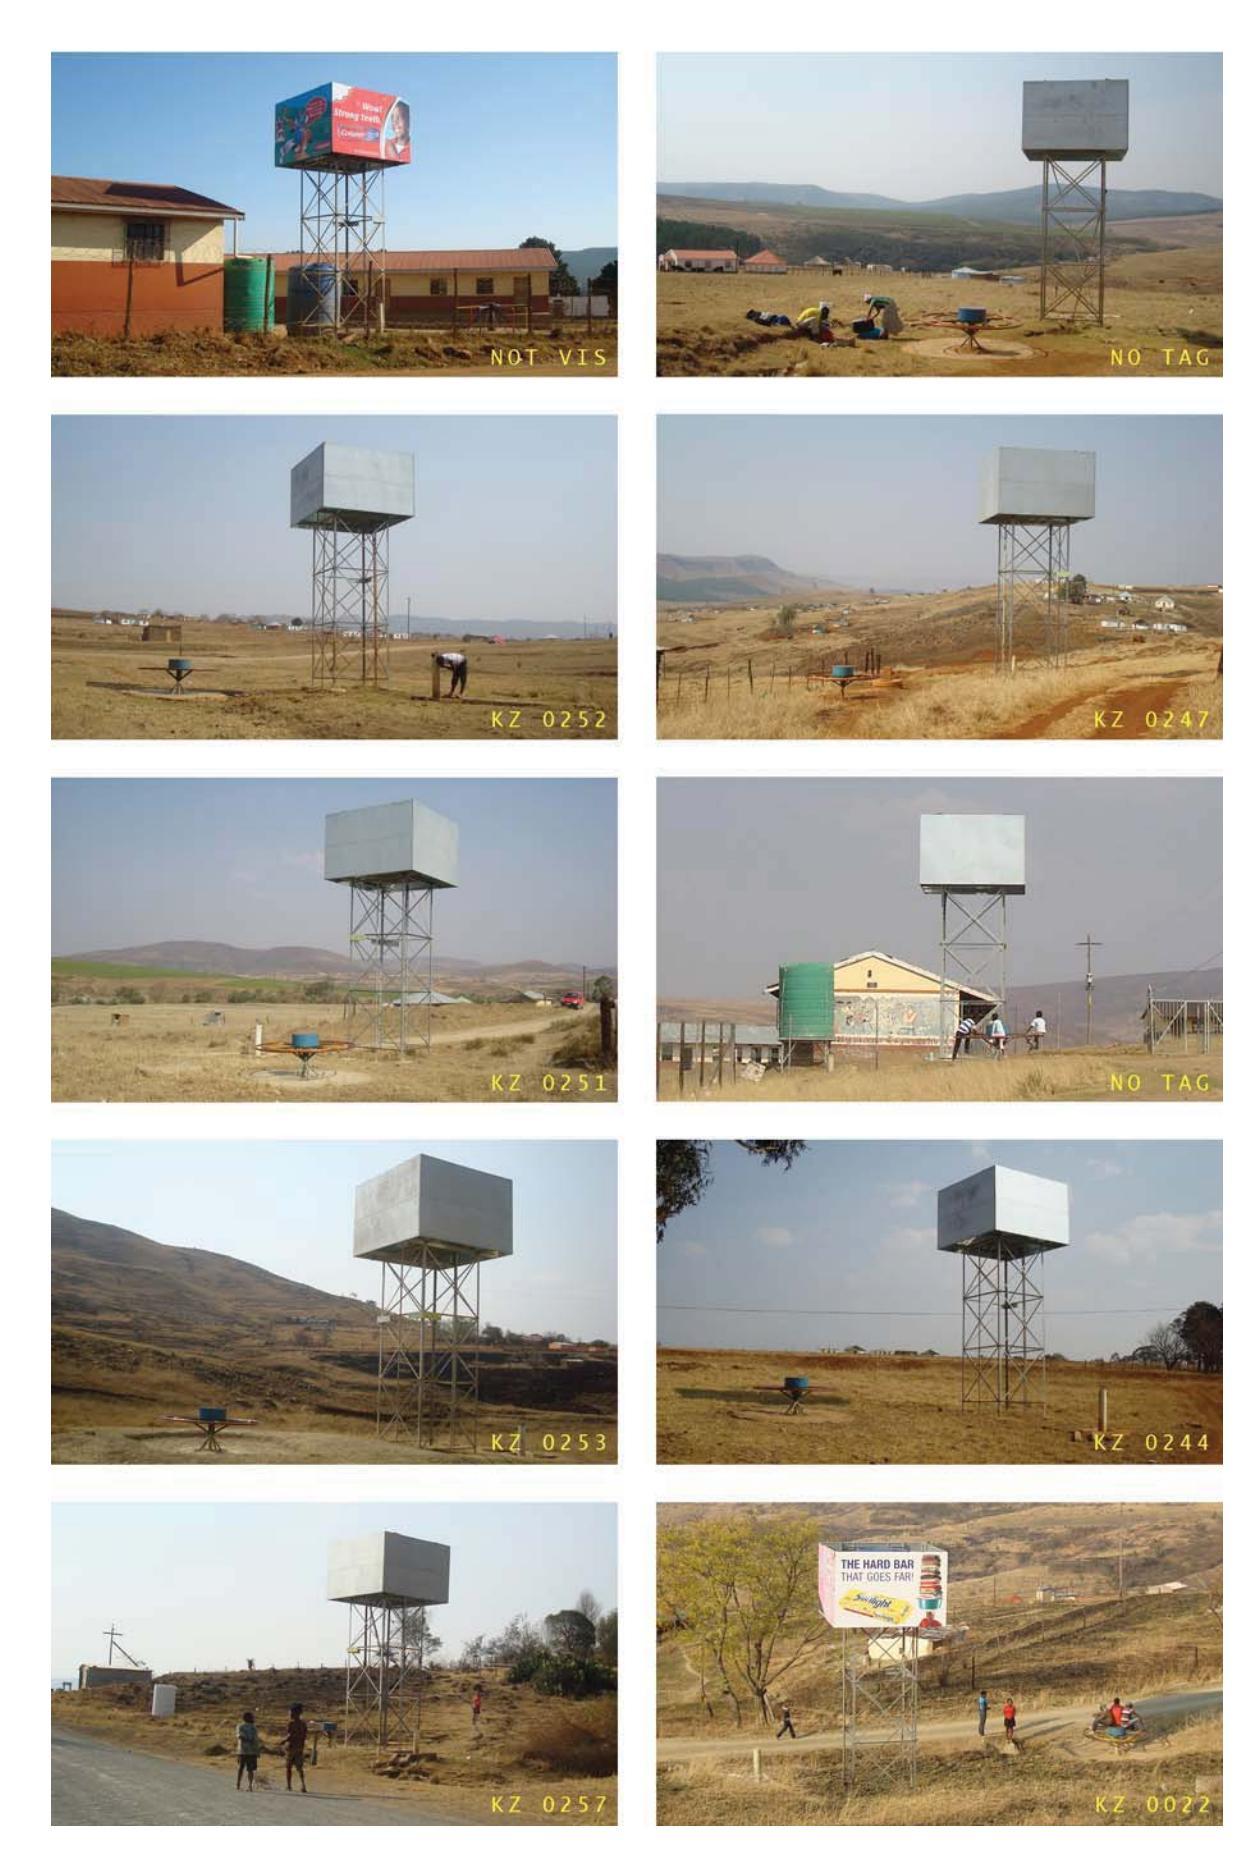
The *PlayPump's* billboards are presented as a means of the project's 'sustainability', and a way for private companies, governments and organisations to reach a poor rural demographic. But, especially in more remote rural areas, far from busy roads – installations that are close to roads have fared better for advertising – the *PlayPump's* billboards are often blank. I have observed this myself on an informal tour of *PlayPump* installations in rural KwaZulu Natal, South Africa in 2010, where 8 out of 10 installations in the area surveyed had no billboard advertisements at all (see fig 7.7, next page).

Fig 7.7 *PlayPump* installations visited in KwaZulu Natal by the author in August 2010, with their Roundabout Outdoor tag numbers, where present/visible.
